# Duct Cutting: MULETAPE® vs. Rope

## Burn Through: The Case for MULETAPE vs. Rope

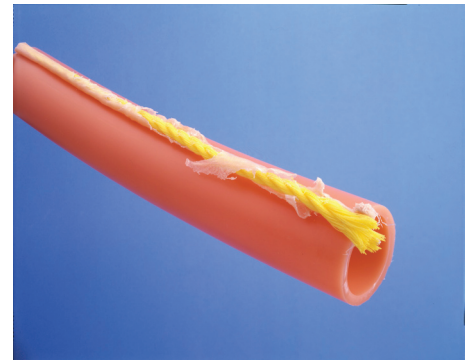
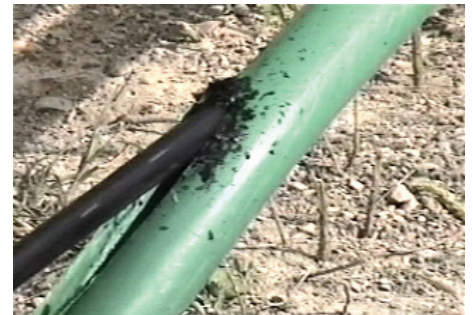
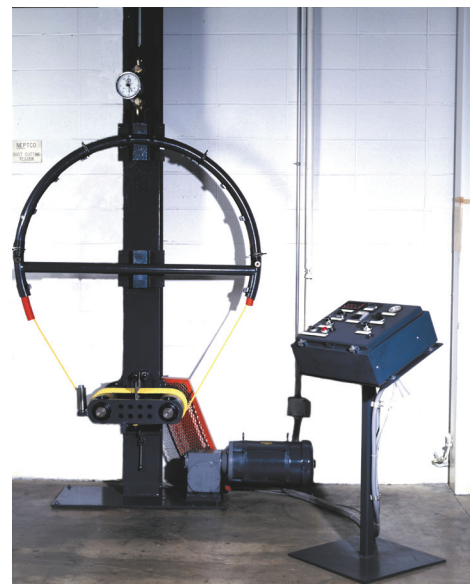
NEPTCO Duct Cut Tester

A: NEPTCO has gone to great lengths to test this theory by duplicating installation conditions in the lab and in the field. Our research engineers designed the Duct Cut Tester to evaluate the performance of various conduit materials and winch lines under typical installation conditions.

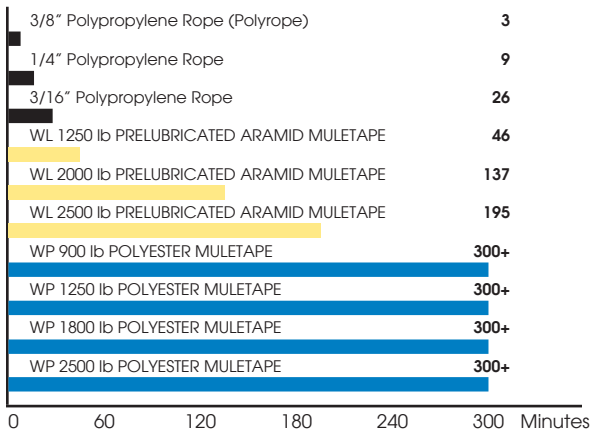
The charts below indicate the time elapsed before conduit experiences damage due to burn through:

**Duct Cutting in Corrugated 1.5" ID HDPE Subduct**

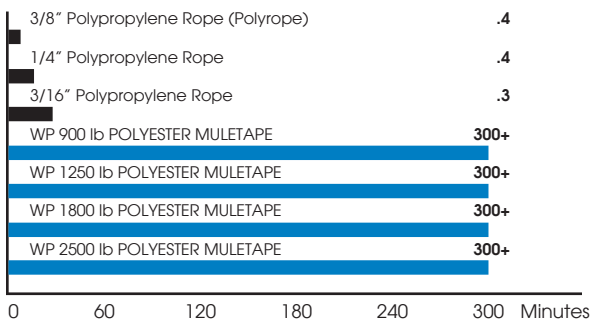
**Duct Cutting in Corrugated 1.5" ID PVC Subduct**

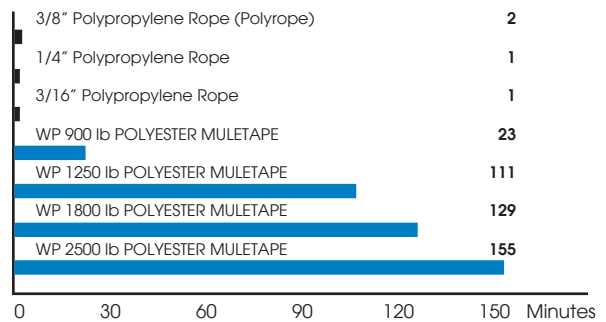
**Duct Cutting in 2" Schedule 40 PVC 90° Subduct**
